Test Bench Cleanliness Standards Challenge Traditional Hydraulic Filtration

KINECOR INC.

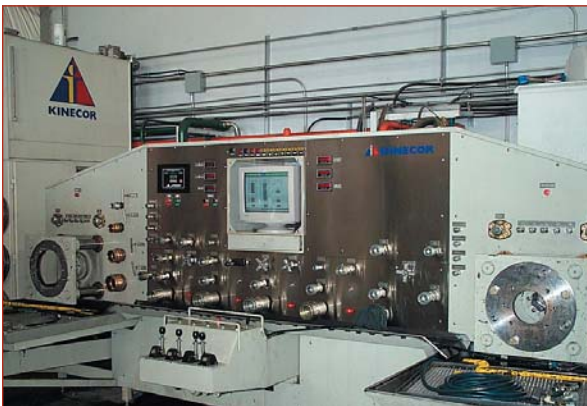
upper left: Kinecor's hydraulic test bench lower left & right: FilterMaster magnetic rod with trapped ferrous contamination (indicated by arrows)

Kinecor offers their customers a hydraulic testing facility to ensure that serviced equipment is functioning properly. It is powered by an 8V92, 470 horsepower, Detroit Engine and has a 300 gallon hydraulic reservoir. A 2-micron filter is installed at each of the two hydraulic returns to protect the \$250,000 test system from older equipment which typically has high levels of ferrous contamination. The filters also ensure new equipment being tested does not become cross contaminated by any wear particles in the test system.
